niGLON

Installation Essentials

Backbox Saver

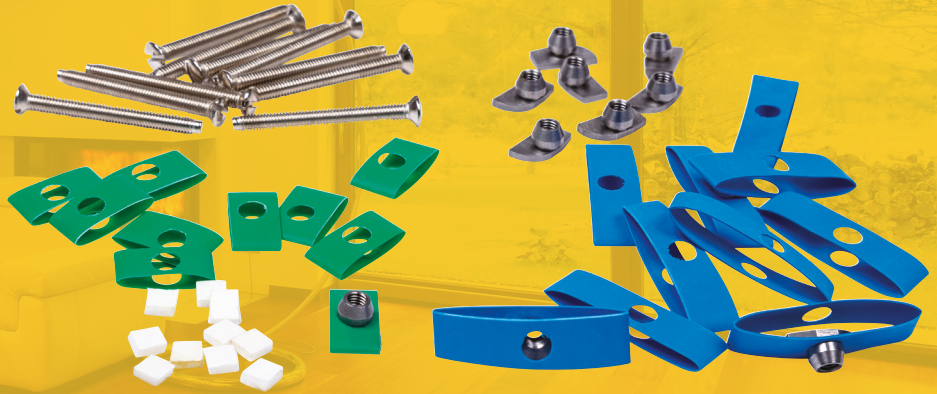
A patented device that solves the problem of stripped threads in electrical backboxes. Although a backbox itself is cheap to replace, once it has been fixed in place and the wall plastered/decorated, or worse tiled, replacement becomes a very difficult and time-consuming ask.
